## Sample Roll Report

## WebRanger - Job 40671 Report

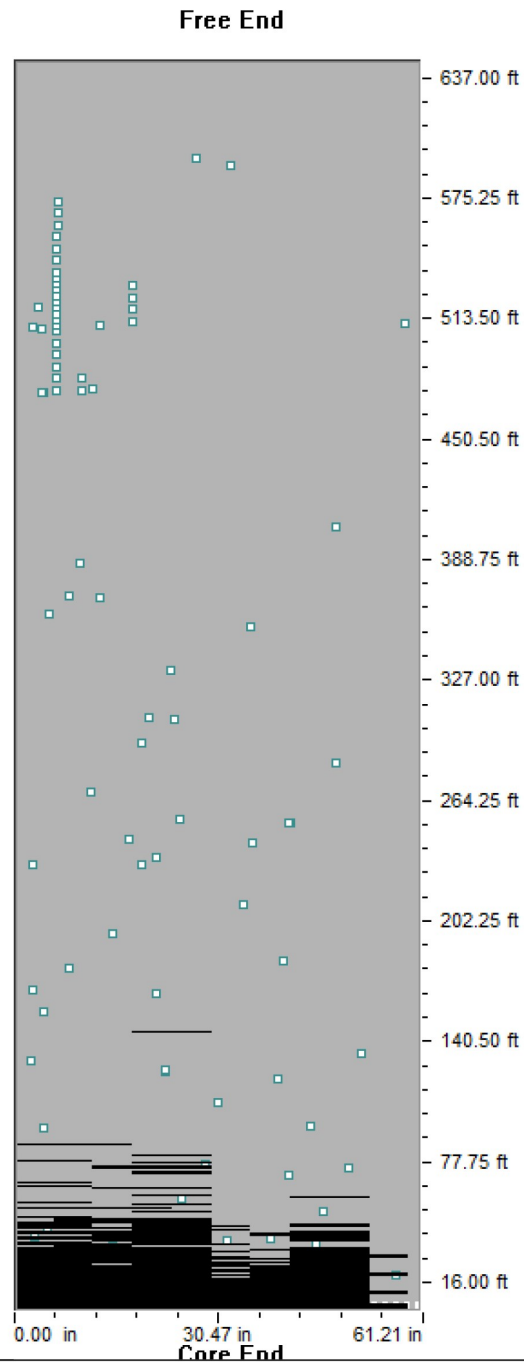
Flaws			
Symbol	Flaw Class	Count	Counts per (Ft2)
D	Large DSpot	94	.028506
G	Large BSpot	1	.000303
	<b>Total</b>	95	.028809
Events			
Resume Inspection		0	
Pause Inspection		0	
Density Event		515	
Start Job		1	
End Job		0
